EAST BOSTON STEAM PUMP STATION
20 Addison Street
Boston
Suffolk County
Massachusetts

HAER No. MA-128

EAST BOSTON STEAM PUMP STATION

This documentation was extracted from the East Boston Pumping Station: Historical, Architectural, Structural and Geotechnical Assessment, dated September 18, 1992 as prepared by Metcalf and Eddy in association with Ann Beha Associates. The assessment was completed in compliance with the National Historic Preservation Act (36 CFR 800) and M.G.L. Ch. 9, ss. 26-27c, as amended (950 CMR 71). The Authority is proposing to demolish the two chimneys at the East Boston Steam Pumping Station (EBSPS) as an emergency response to public safety issues. The demolition of these chimneys would constitute an adverse effect (36 CFR 800.9 (b)(1) and 950 CMR 71.05 (a)) to the National Register eligible property.

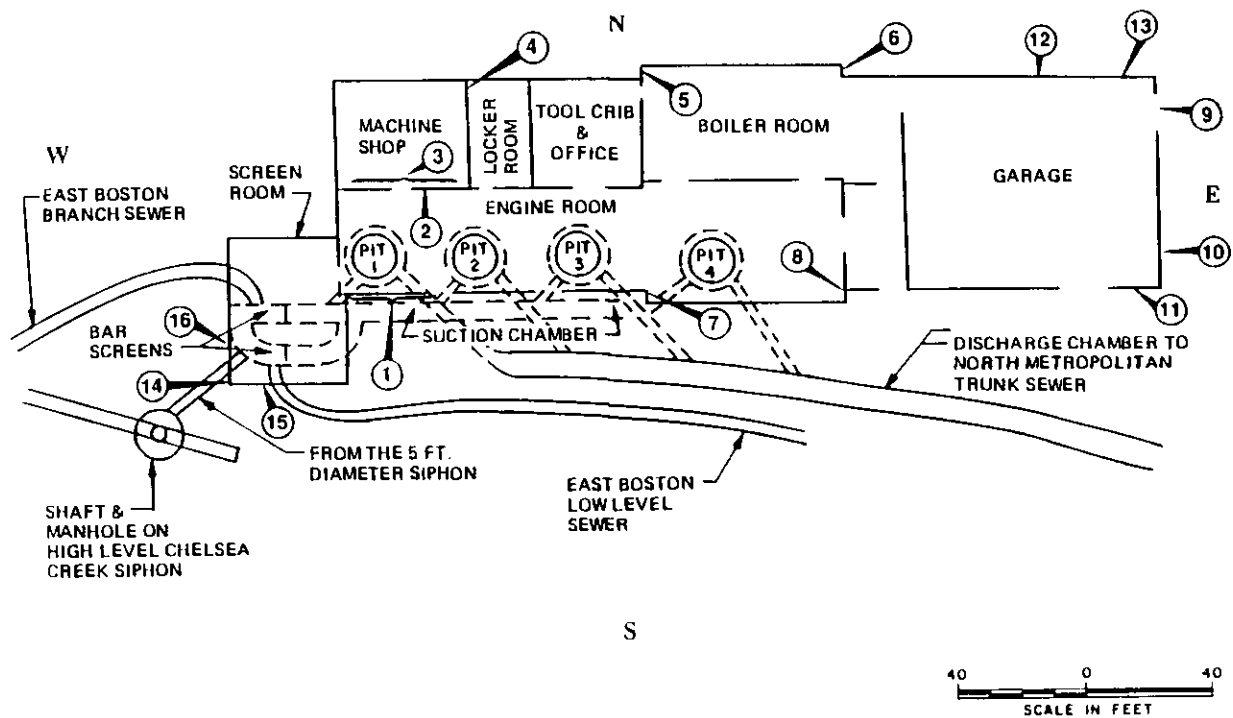
Figure 3-2 - Crack Location Plan
East Boston Steam Pumping Station Historical, Architectural, Structural Assessment:
September 18, 1992

Cracking of brick masonry walls is evident at a number of locations. Settlement at the southwest corner of the Screen House is apparent. The bottom 3 feet of the corner appears to be rotating downward resulting in a stepped, tapered crack which is widest at the outside corner. A 1/2-inch wide vertical crack is also visible nearby penetrating the granite sill, masonry wall, and granite water table of the westernmost window opening of

the south wall of the outside corner. A 1/2-inch wide vertical crack is also visible nearby penetrating the granite sill, masonry wall, and granite water table of the westernmost window opening of the south wall of the Screen House.

Long vertical cracks exist at the narrow returning walls connecting the south wall of the central pavilion to each of its flanking wings. These cracks run the full height of the wall and taper from narrow at the bottom to approximately 3/4-inch at the top of the cornice. These cracks are probably due to the gradual expansion or lengthening of the main masonry walls and parapet walls, whose bricks slowly absorb moisture over time and may expand approximately 0.2% over the uninterrupted length of the wall. Commonly, expansion joints would have solved the problem, but buildings from this period typically do not have them. Using the above percentage and applying it to the individual lengths of the south walls of the two wings and the central pavilion, one may see that each of the two south wing walls may have increased in length by approximately 2 1/2 inches and the south wall of the main pavilion may have increased in length by approximately 1 1/2 inches. Such a condition would in effect attempt to rotate the short wall but typically the wall is sheared vertically and the crack results. This same situation may exist at the southeast corner of the eastern wing where patching of some rather large vertical cracks is evident at the corner quoins. These cracks are best raked out and filled with a backer rod and a flexible sealant to prevent further moisture penetration and to allow for future movement.

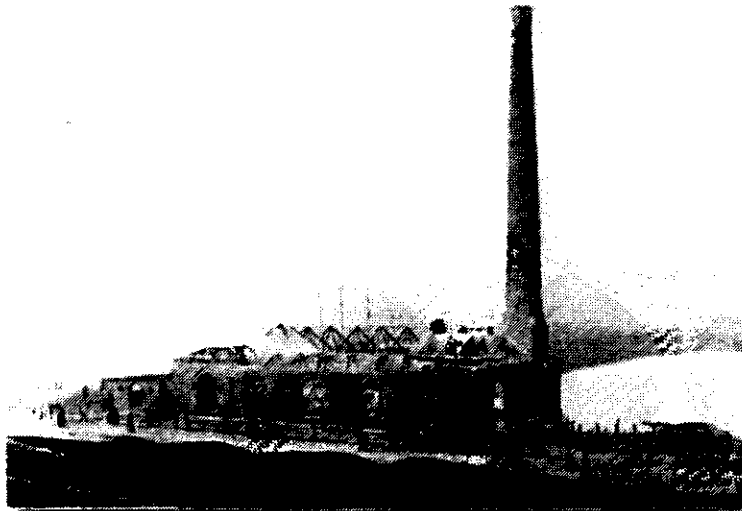
3. East Boston Steam Pumping Station - April 1908
Massachusetts Water Resources Authority's Record Center

The fire entirely destroyed roofs, doors, windows, coal house and wharf at this station. The girders and most of the piping of the station were a mass of twisted iron and steel. The walls were scarred and cracked and had fallen in places.

EAST BOSTON STEAM PUMP STATION, AFTER FIRE OF APRIL 13, 1908
OUTSIDE END, FRONT
